PM Problem Solving Using Metallography

Abstract – Metallographic investigations have always been useful to find out the reasons for failure. The present paper contains PM industrial examples where the problems have been solved with the help of microstructural analysis. This analyses will help PM customers to become more aware about microstructures and their importance in order to produce better quality products and taking PM to a higher level.

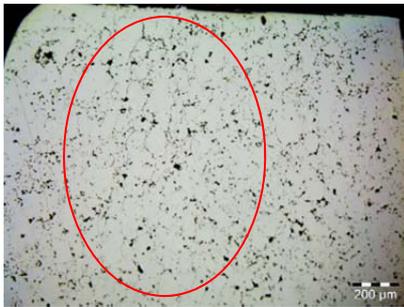
The customer noticed lower strength in the component inspite of using a high performance material Distaloy[®] HP. When the microstructure was investigated, cracks were found in the tooth. This was found to be the reason for the lower strength of the component (Fig. 4).

Fig.4: Encircled cracks present in the tooth of the component.

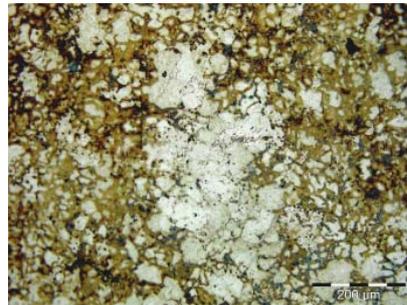
Component was made using Fe + 2% Cu + 0.3% MnS + 0.8% Lubricant. The Sintering was carried out at 1120°C for 30 min in 90/10 N₂/H₂ atmosphere. The component had machinability problem and experienced high tool wear.

The microstructure present in the part contained ferritic grains with brown Cu rich areas (Fig. 5) Ferrite is a soft phase compared to other phases and structure like pearlite. Here the ferrite created

Fig. 5: Ferritic microstructure present in the component

problems as it sticks to the tool. A solution here could be either to use another type of tool or have a small carburization of the surface during sintering which could improve the machinability of the material.

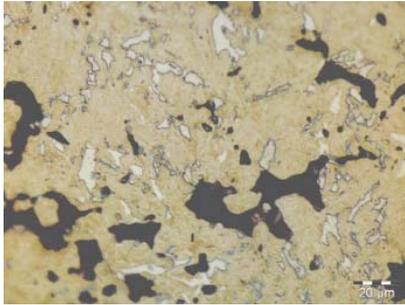
A component got cracks after induction hardening. The carbon content was 0.35% which is low for a material that is Induction hardened. The microstructure in the sample was martensite with few areas of ferrite, white spots in (Fig. 6), in the induction hardened area. The ferrite areas in the martensite means that the part was not fully austenitized during the induction hardening². Since ferrite and martensite have different tendency to grow it can result in the crack formation. It was suggested to revise the induction hardening parameters so that the part is fully austenitized another alternative could be to increase the carbon content in order to fully austenitize the material at lower temperatures.

Fig.6: The microstructure in the induction hardened area of the component

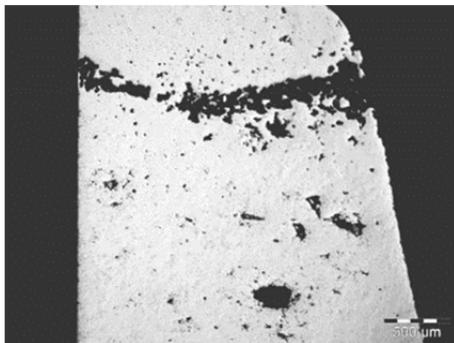
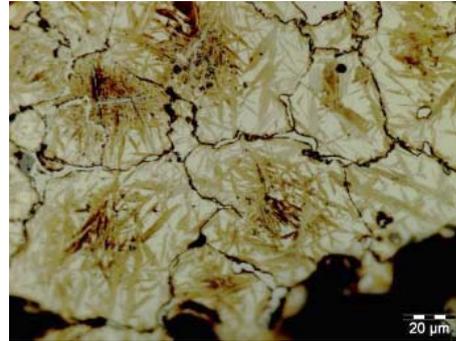
The customer was getting blow holes on the surface of the components. These defects were noticed during face machining at the time of assembly at OEM place. The un-etched microstructure revealed that there were large pores and voids in the component (Fig. 7). In the etched structure near the defect the microstructure was martensite with large amount of retained austenite and cementite while the normal area contained martensite. This means that the defect was caused by something that had high carbon content. In this case it was caused by agglomeration of graphite. This component generally contain high content of graphite in the mix which often leads to agglomeration and results in blow holes. Höganäs's bonded mixes will help to avoid agglomeration hence, it was suggested to use a bonded mix instead of a premix.

Fig. 7: The microstructure present in the component near the defect.

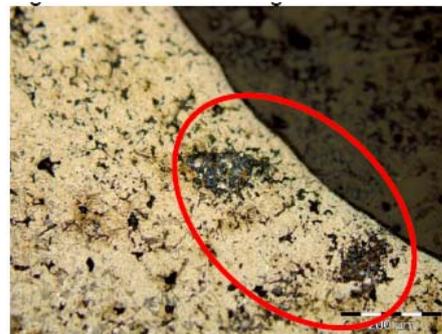
The heat treatment parameters for PM parts is often different than conventional as it contained pores. Due to the pores, the penetration rate of carbon increases for these parts. It is generally observed that in PM gears, tooth and tooth root shows different microstructure probably due to difference in cooling rate. In this case a small amount of bainite-soft areas were present in the tooth root of the gear, which will decrease the strength in the tooth root (Fig. 8). Here the heat treatment parameters needs to be adjusted in order to have a fully martensitic structure at the surface of the tooth root.

Fig. 8: Heat treated gear contained bainitic areas in the tooth root
