# Evaluation of Wear in an Automotive Transmission using Powder Metal (PM) Gears

Dr. Anders Flodin

## Abstract

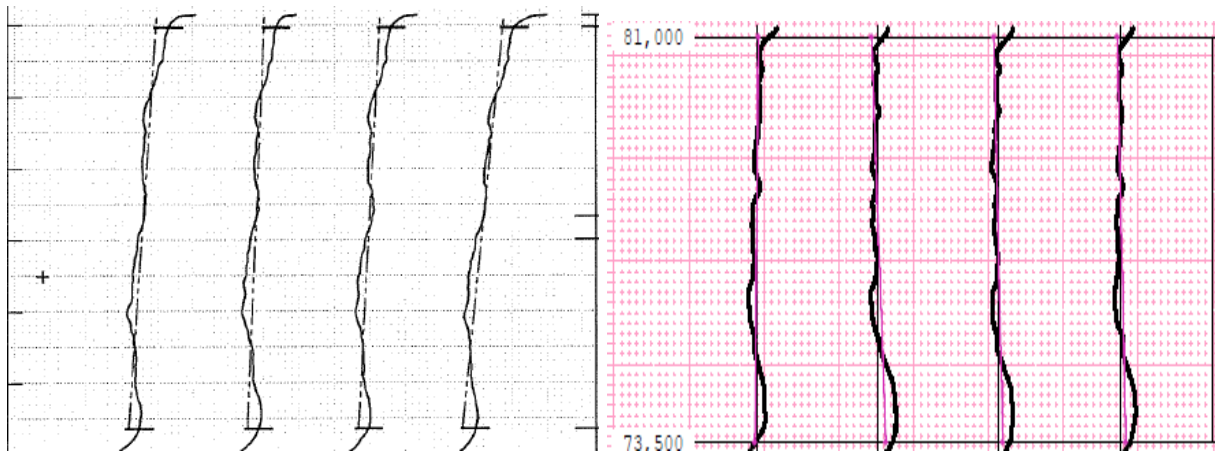
Fig. 2. Flank form. Left: Before running. Right: After running.

Figure 2 shows an attempt to depict the flanks of the gears before and after running. The two measurements were made on different machines. The graph to the left is from a Klingelnberg CMM, and the graph to the left is from a Zeiss. The machines have provided very similar results in previous benchmarking. The same gear teeth at exactly the same positions have not been measured either, but it is the same gear. The ball diameter of the probe is 1.5 mm in both measurements and the evaluation lengths and diameters are the same. As can be seen there are no anomalies created on the teeth surfaces after running, and the wear can be regarded as mild with detectable wear at the root of the pinion. This is normal and is caused by the sliding distance in the root being longer than anywhere else on the tooth surface. It is important to note that the wear depth affecting transmission error and noise is

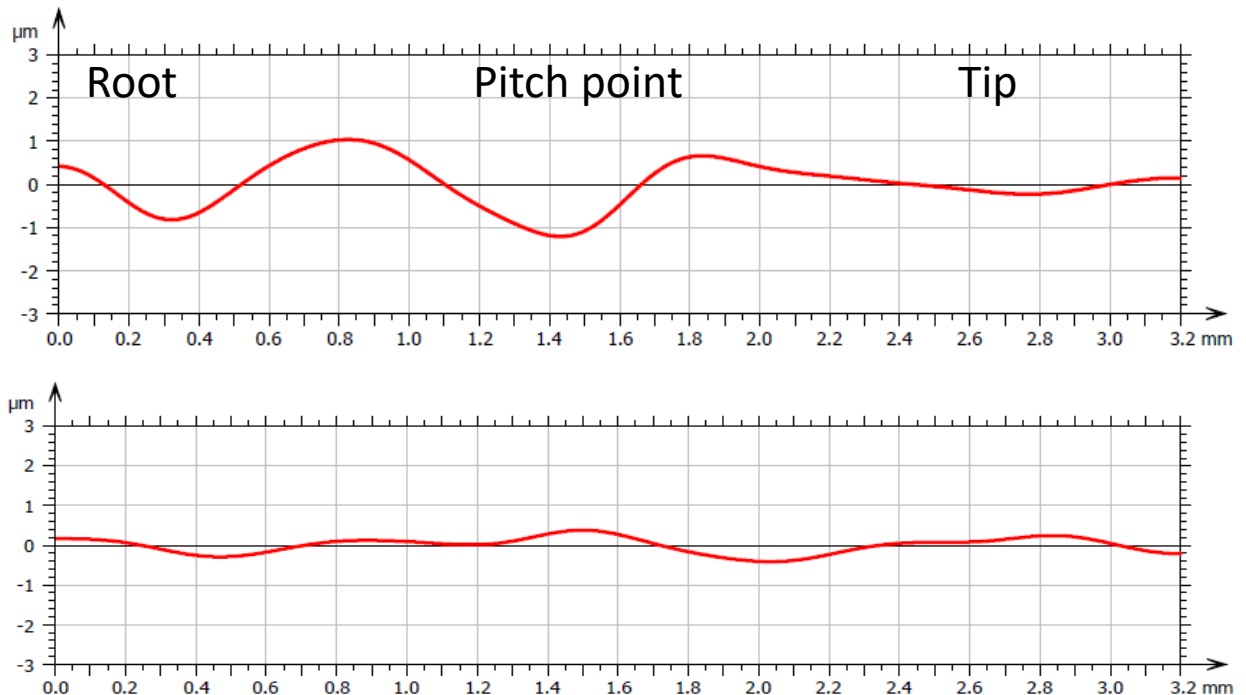
Fig. 3. Waviness on drive side (upper graph) and coast side (lower graph).

Figure 3 shows the worn drive side of the 5:th gear with the involute removed by a 4:th order polynomial. A Gauss filter with a cut-off length of 0.8 mm has removed the roughness. The lower graph in figure 3 shows the coast side which can be assumed to be unworn. The waviness amplitude in the upper graph is about 2 microns while it is less than 1 micron in the lower graph. Caution should be exercised when working with filtered graphs, but from a macro point of view there is not a lot of material worn off. Only wear estimates can be made from Figure 2 and 3 and it is not possible to numerically quantify the wear due to the filtering technique used.

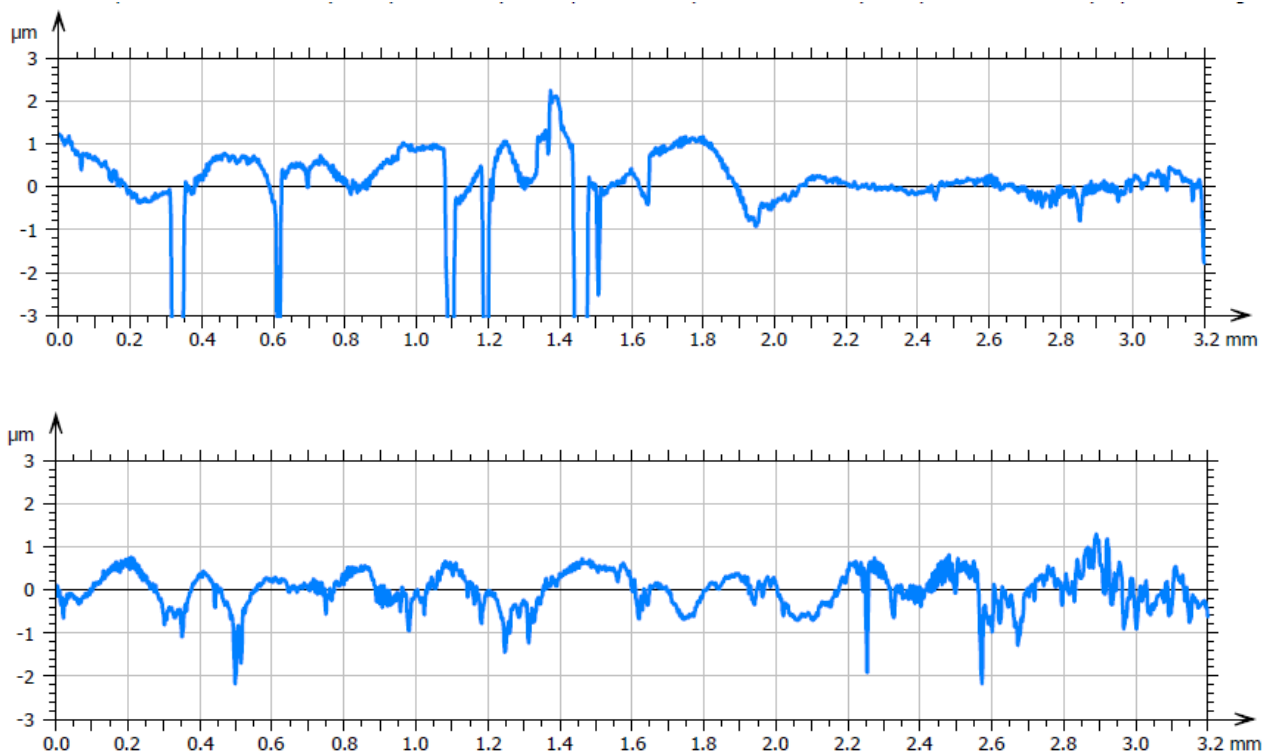
*Fig.4. The residual after filtering out the curve in Figure 3. The upper graph is the worn surface and the lower graph is from the coast side so regarded as unworn.*

In Figure 4 the surface roughness is presented. The upper graph is the worn surface of the 5:th pinion and the lower graph is the same tooth but on the coast side. The coast side can in this case be considered as unworn. The worn side shows what looks like holes in the surface but only below the pitch point. This is not uncommon for worn ground gears [1]. Above the pitch point the surface roughness has been smoothed and is less rough than the unworn coast side. The asperities from grinding have been worn down to create a smoother finish and the surface has just been worn in. These observations are normal for a pinion [1].

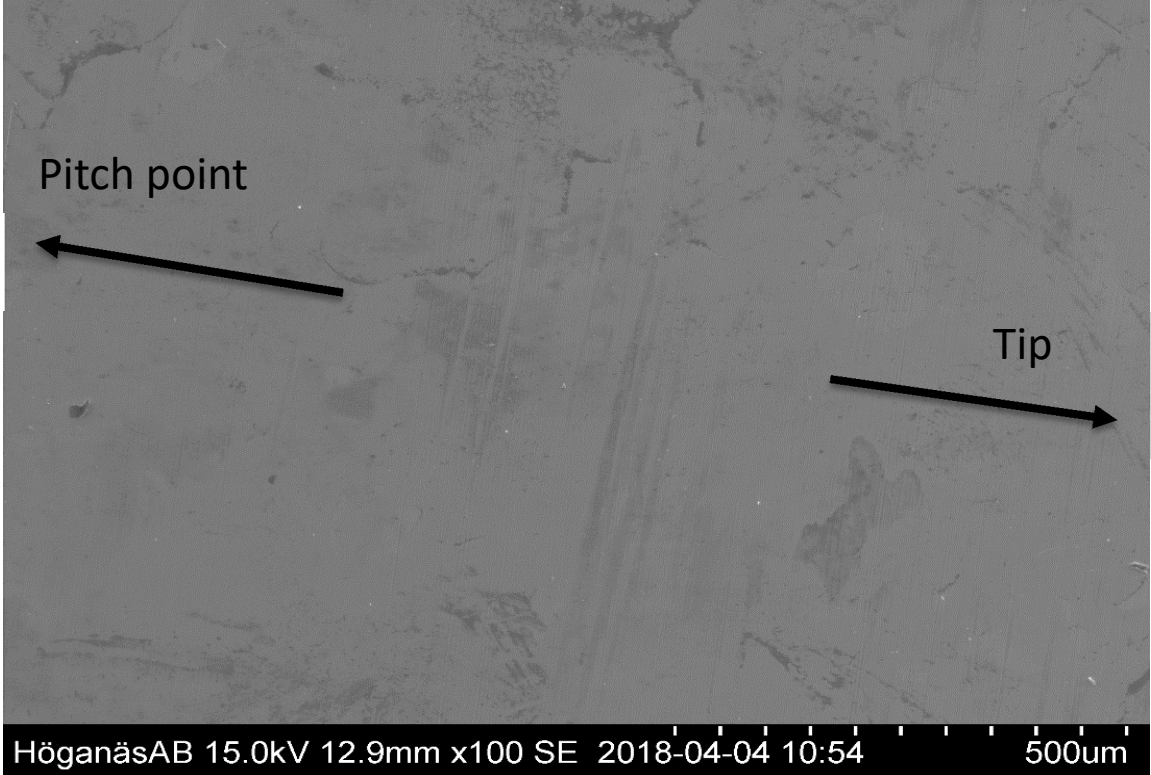
In a SEM it is possible to derive more information from the surfaces. In Figure 5 the area above the pitch point is shown corresponding to 2-3 mm in the upper graph of picture 4. The wear is just through the grinding marks and these are still somewhat visible. Wear depths of

approximately 2-4  $\mu\text{m}$  can be deduced from the roughness graphs in Figure 4. The wear in the root can be expected to be a little deeper as seen in Figure 3 and 4.

Fig. 5. SEM image of the area above the pitch point.

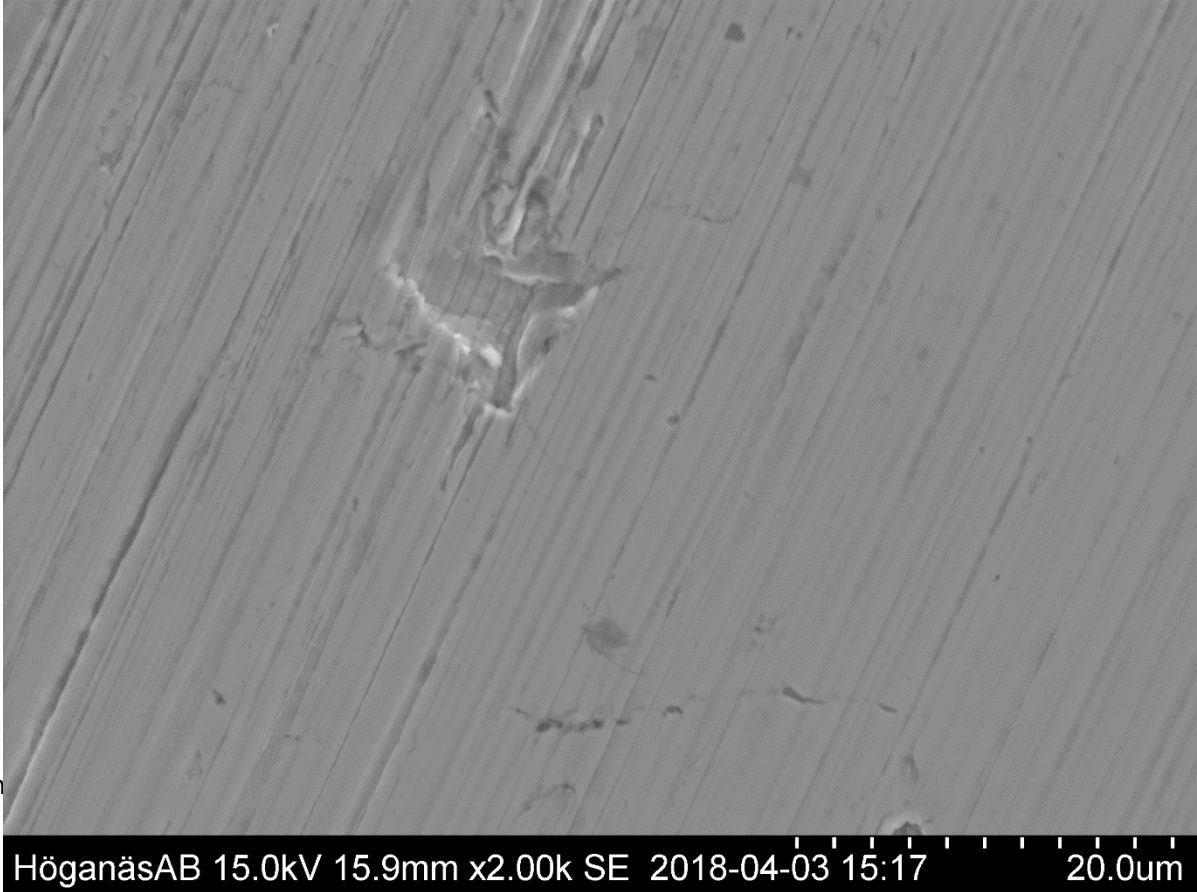
drops out of the scale. In Figure 7 the SEM zooms in on a dimple just above start of active contact.

*Fig. 7. Surface defect below pitch point.*

It is interesting to note that it looks like there are grinding marks at the bottom of the defect in figure 7. This implies that the asperities have maybe broken off into several pieces, but no deeper than the deepest grinding marks, or the defect was already there during grinding, or it is not grinding marks at the bottom and there is a pit gradually forming. Either way, the defects on the surface after running is not bigger than the one in figure 7 which shows how well the surface stood up to the loads and cycles.

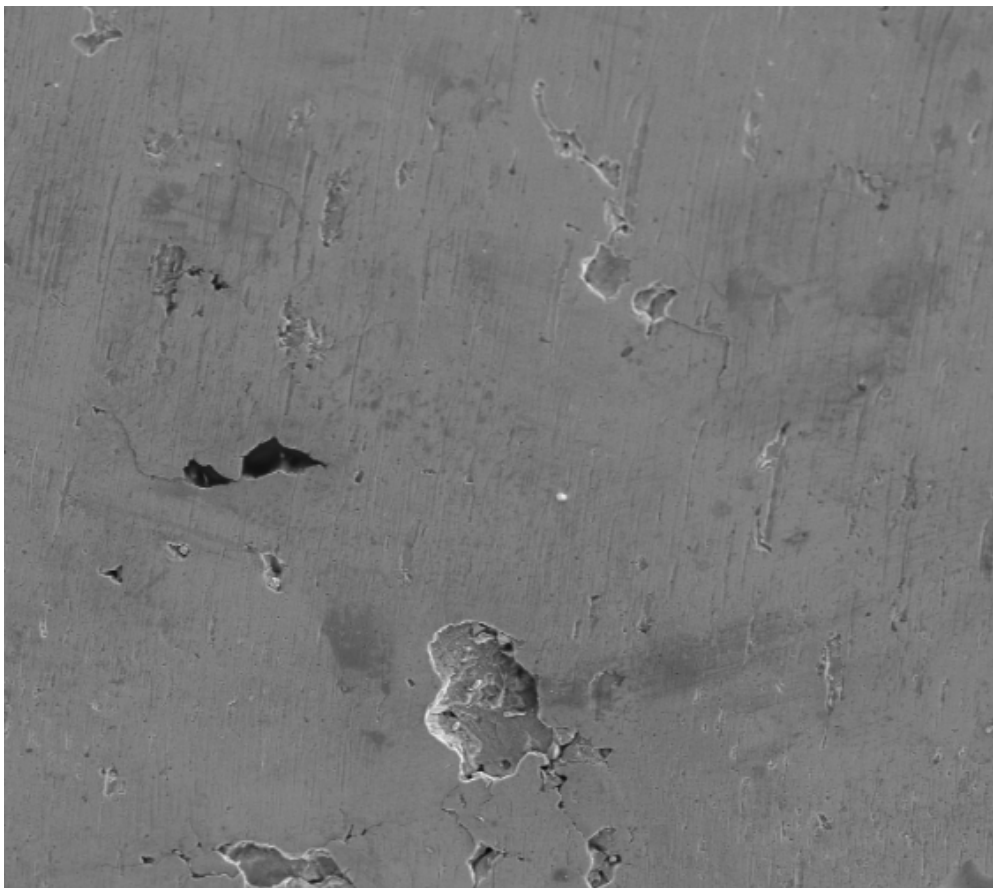
In Figure 8 some damage at the start of the mesh is shown. This part of the pinion is often the most susceptible to wear because the contact conditions are not optimal. The models in the software for tip relief have difficulties simulating the conditions here. Figure 9 shows the start of the contact and it is evident that there is hard line contact indicating insufficient relief in the area circled in red. This normally is self balancing due to the wear and the wear rate is very high in the beginning but recedes with cycles. The pit in figure 8 has no cracks around its perimeter indicating that it is not growing due to low load bearing. The load bearing is done by the other gear pair in mesh.

*Fig. 8. Deep in the root area some surface damage is deeper than grinding marks.*

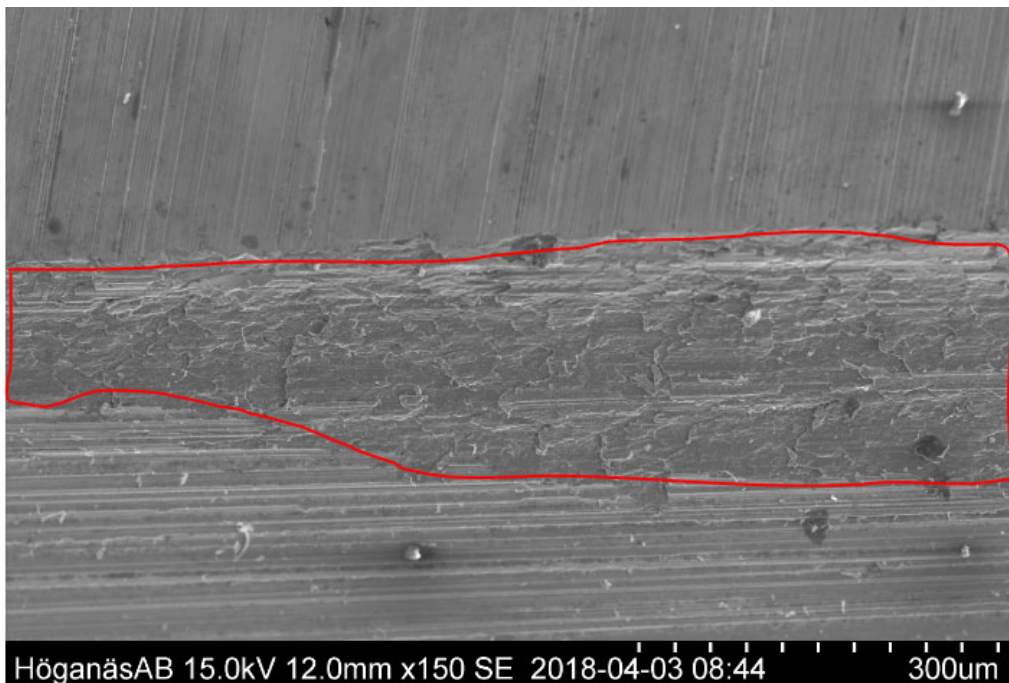
*Fig. 9. Start of contact. Red circled area is severe wear.*
