Evaluation of Wear in an Automotive Transmission using Powder Metal (PM) Gears

Anders Flodin

Abstract

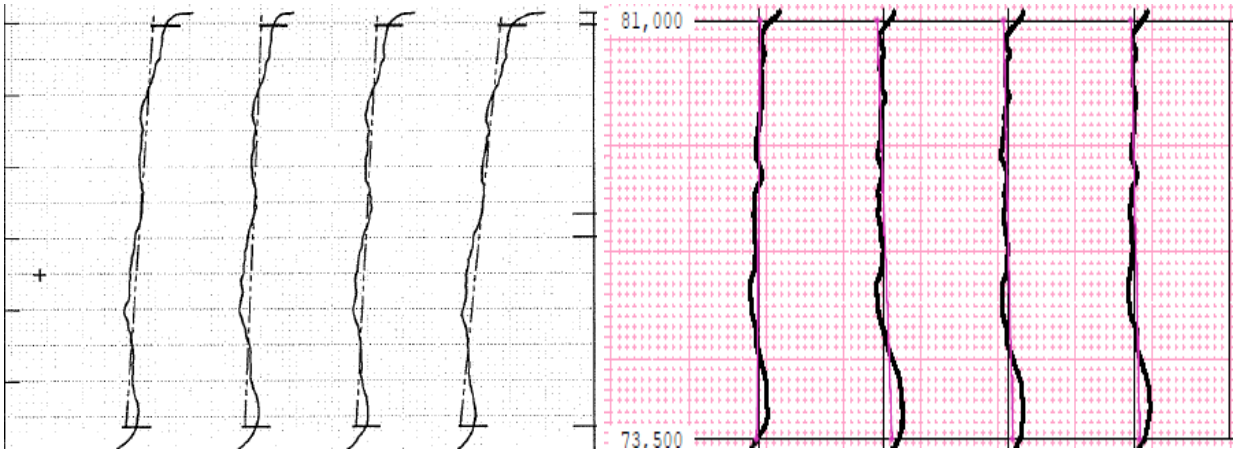
Fig. 2. Flank form. Left: Before running. Right: After running.

Figure 2 shows an attempt to depict the flanks of the gears before and after running. The two measurements were made on different machines. The graph to the left is from a Klingelnberg CMM, and the graph to the left is from a Zeiss. The machines have provided very similar results in previous benchmarking. The same gear teeth at exactly the same positions have not been measured either, but it is the same gear. The ball diameter of the probe is 1.5 mm in both measurements and the evaluation lengths and diameters are the same. As can be seen there are no anomalies created on the teeth surfaces after running, and the wear can be regarded as mild with detectable wear at the root of the pinion. This is normal and is caused by the sliding distance in the root being longer than anywhere else on the tooth surface. It is important to note that the wear depth affecting transmission error and noise is just a few microns, and not tens of microns. In addition, no NVH related transmission issues were ever reported from the drivers during its lifetime.

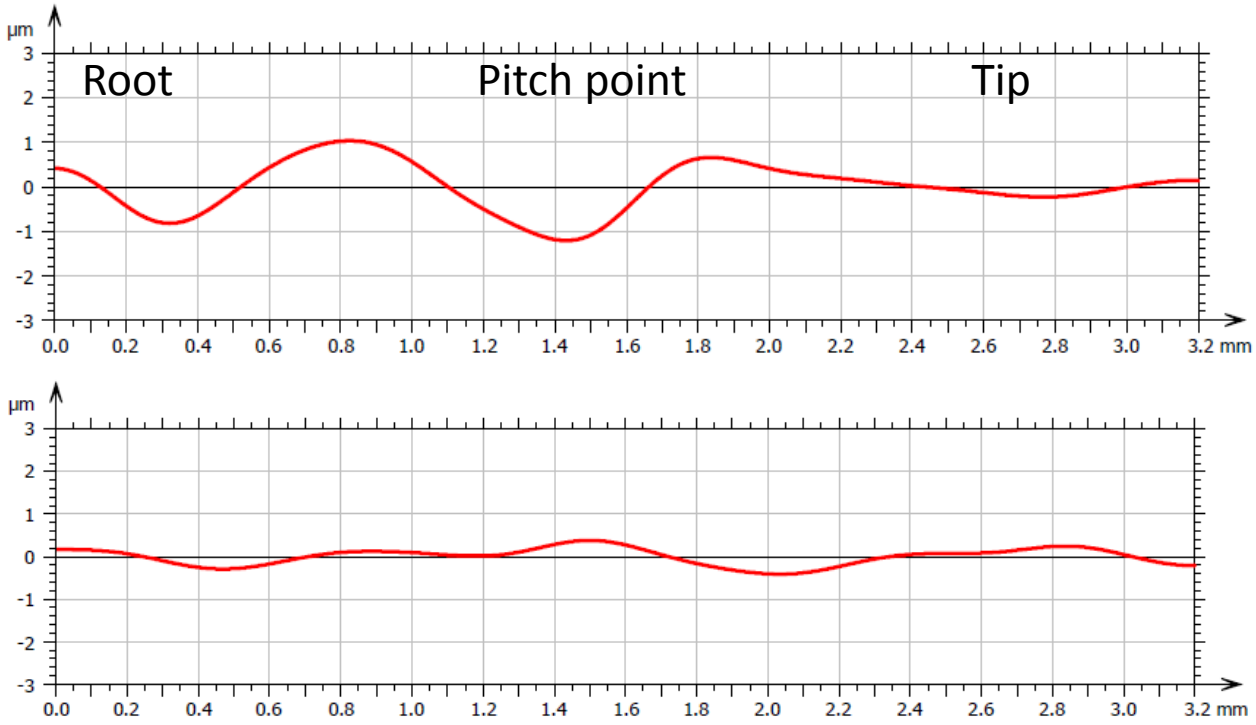
Fig. 3. Waviness on drive side (upper graph) and coast side (lower graph).

Figure 3 shows the worn drive side of the 5:th gear with the involute removed by a 4:th order polynomial. A Gauss filter with a cut-off length of 0.8 mm has removed the roughness. The lower graph in figure 3 shows the coast side which can be assumed to be unworn. The waviness amplitude in the upper graph is about 2 microns while it is less than 1 micron in the lower graph. Caution should be exercised when working with filtered graphs, but from a macro point of view there is not a lot of material worn off. Only wear estimates can be made from Figure 2 and 3 and it is not possible to numerically quantify the wear due to the filtering technique used.

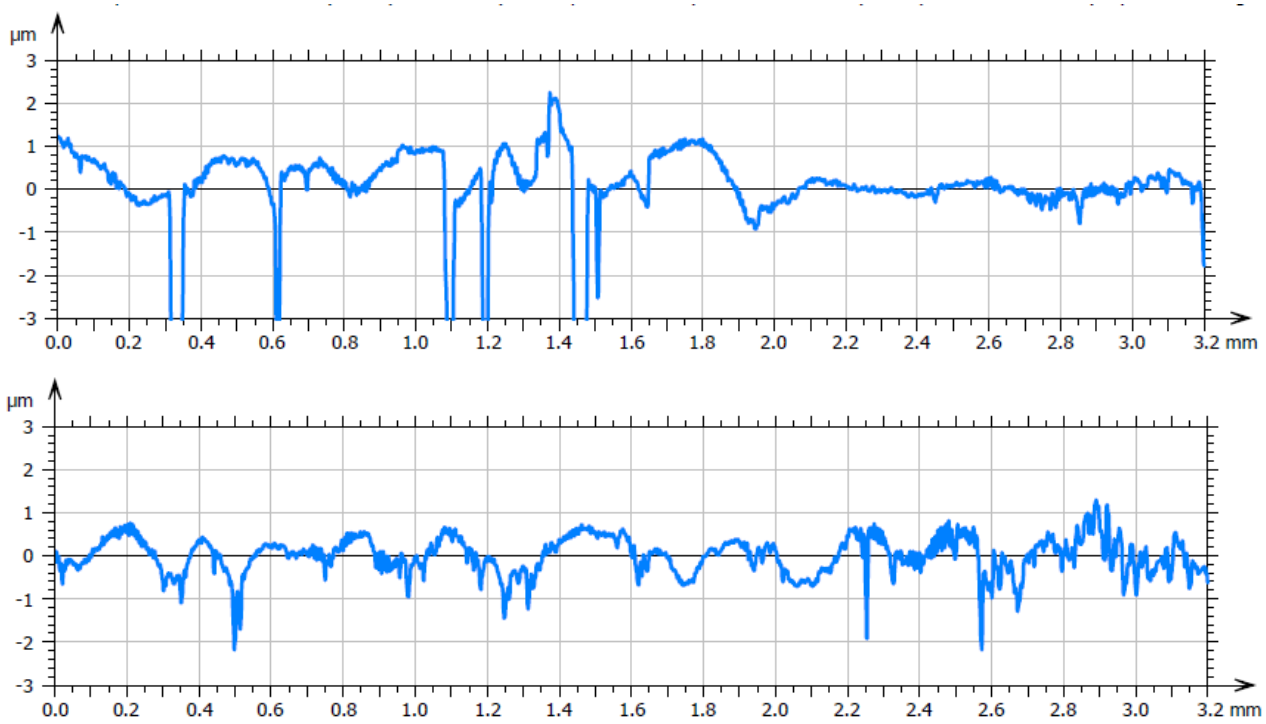
Fig.4. The residual after filtering out the curve in Figure 3. The upper graph is the worn surface and the lower graph is from the coast side so regarded as unworn.

In Figure 4 the surface roughness is presented. The upper graph is the worn surface of the 5:th pinion and the lower graph is the same tooth but on the coast side. The coast side can in this case be considered as unworn. The worn side shows what looks like holes in the surface but only below the pitch point. This is not uncommon for worn ground gears [1]. Above the pitch point the surface roughness has been smoothened and is less rough than the unworn coast side. The asperities from grinding have been worn down to create a smoother finish and the surface has just been worn in. These observations are normal for a pinion [1].

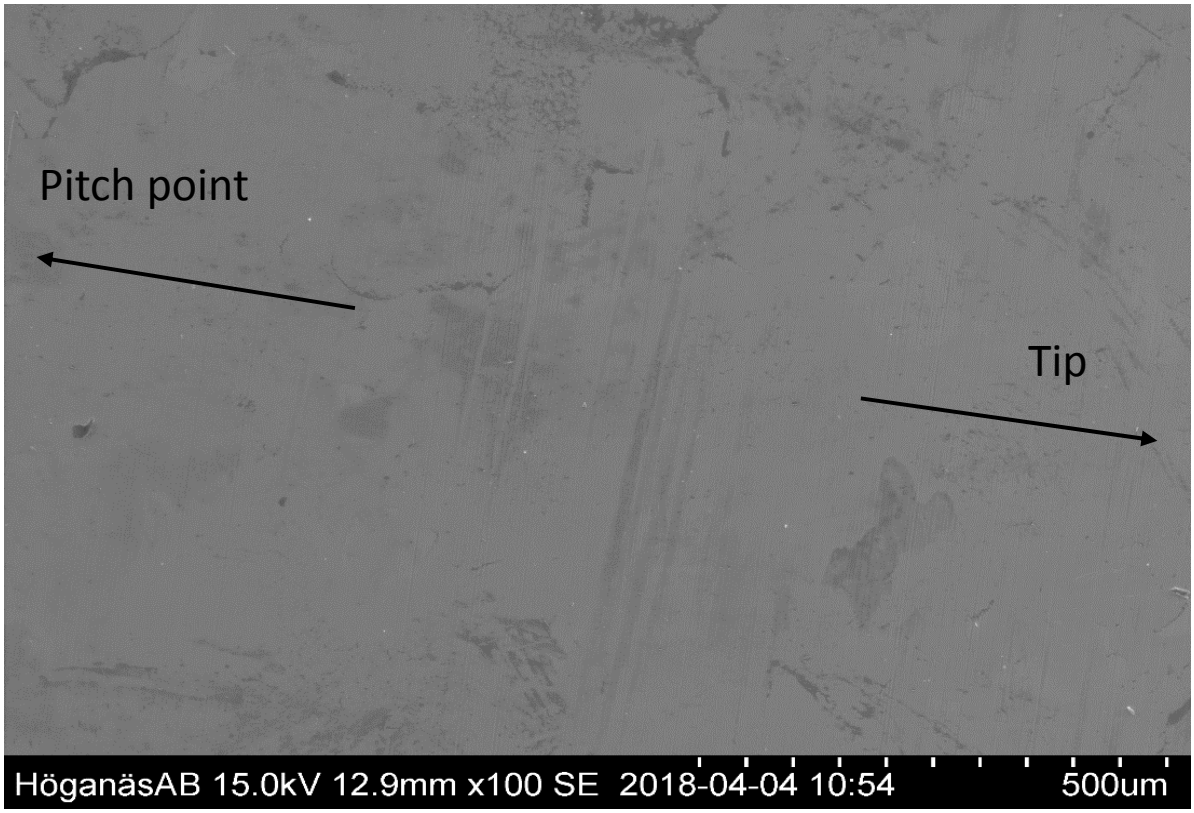
In a SEM it is possible to derive more information from the surfaces. In Figure 5 the area above the pitch point is shown corresponding to 2-3 mm in the upper graph of picture 4. The wear is just through the grinding marks and these are still somewhat visible. Wear depths of approximately 2-4 µm can be deduced from the roughness graphs in Figure 4. The wear in the root can be expected to be a little deeper as seen in Figure 3 and 4.

Fig. 5. SEM image of the area above the pitch point.

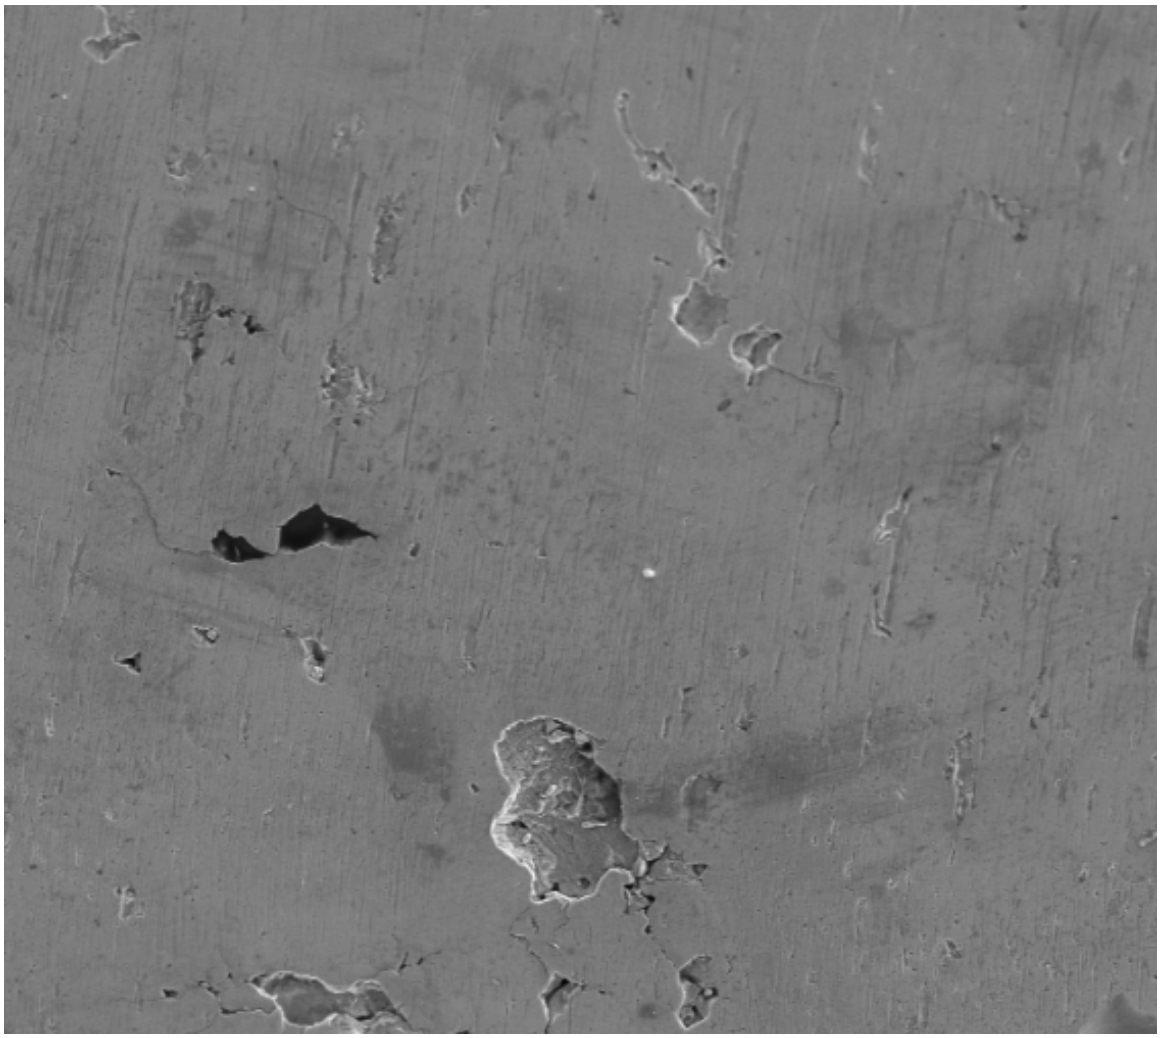
In Figure 8 some damage at the start of the mesh is shown. This part of the pinion is often the most susceptible to wear because the contact conditions are not optimal. The models in the software for tip relief have difficulties simulating the conditions here. Figure 9 shows the start of the contact and it is evident that there is hard line contact indicating insufficient relief in the area circled in red. This normally is self balancing due to the wear and the wear rate is very high in the beginning but recedes with cycles. The pit in figure 8 has no cracks around its perimeter indicating that it is not growing due to low load bearing. The load bearing is done by the other gear pair in mesh.

Fig. 8. Deep in the root area some surface damage is deeper than grinding marks.

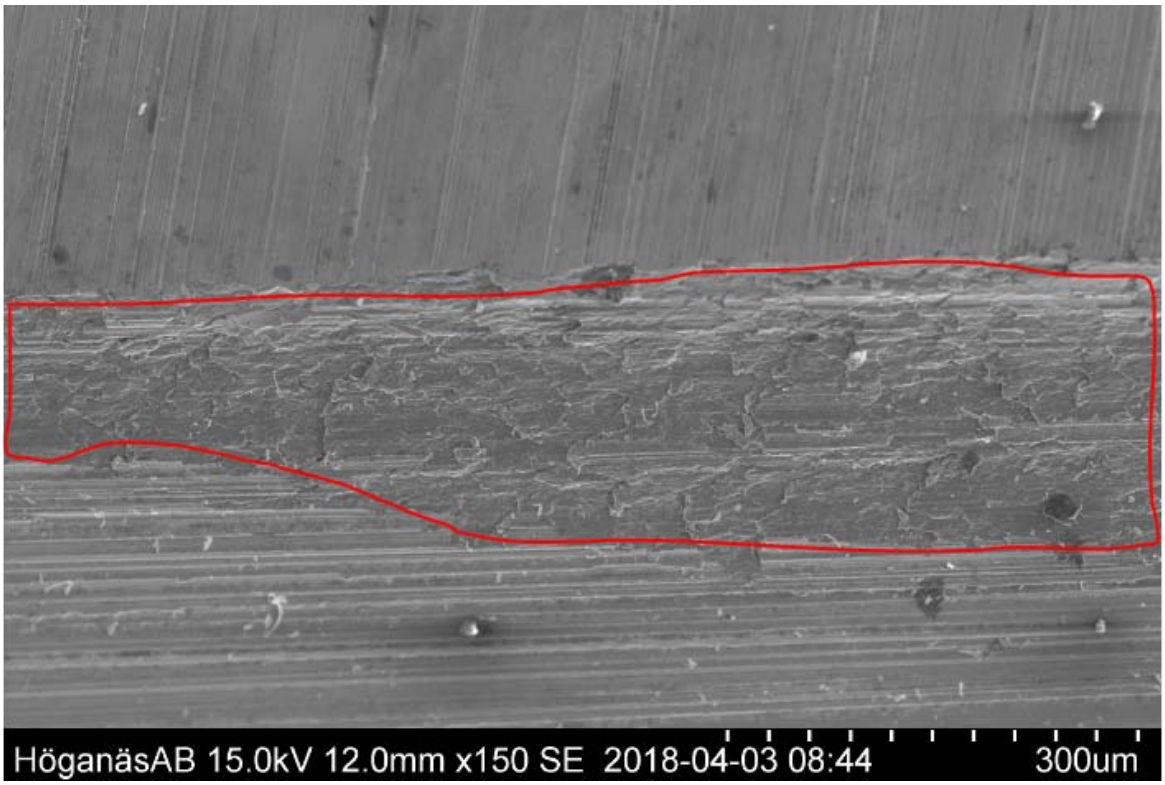
Fig. 9. Start of contact. Red circled area is severe wear.
