PM Problem Solving Using Metallography

Abstract – Metallographic investigations have always been useful to find out the reasons for failure. The present paper contains PM industrial examples where the problems have been solved with the help of microstructural analysis. This analyses will help PM customers to become more aware about microstructures and their importance in order to produce better quality products and taking PM to a higher level.

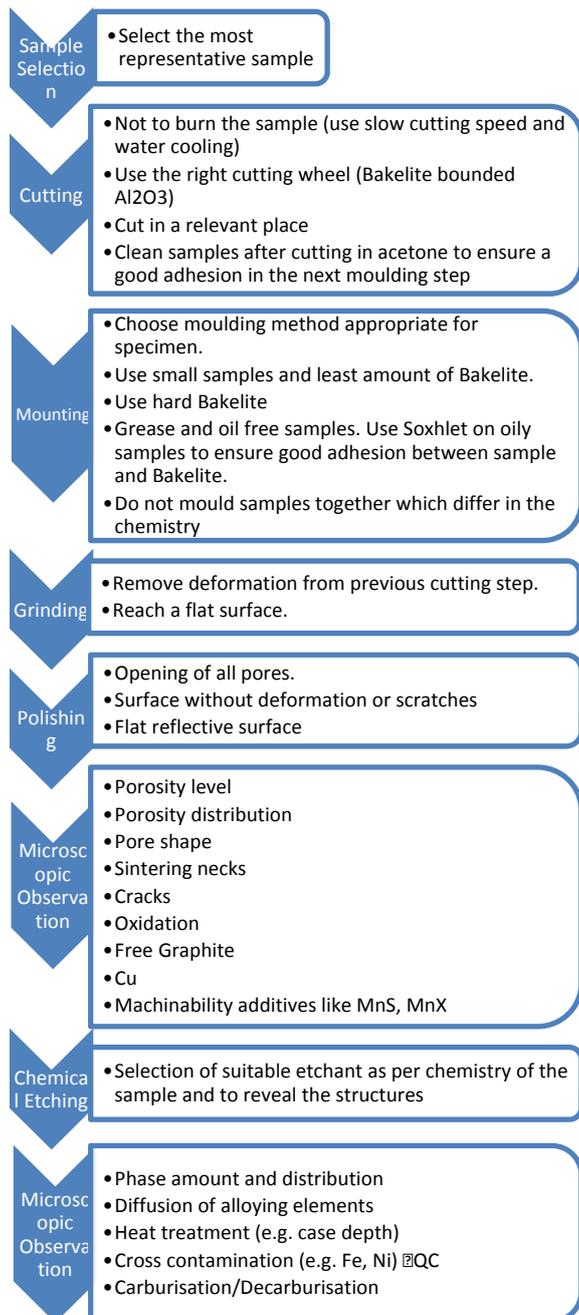
Fig.1: Process flow for metallographic sample preparation and investigation.

component during sample preparation which could lead to the wrong interpretation of the failure. The flow diagram in Fig 1 provides the order of the sample preparation and investigation steps carried out for metallography investigation. It also shows what needs to be considered in each step in order to minimize the artifacts caused by sample preparation.

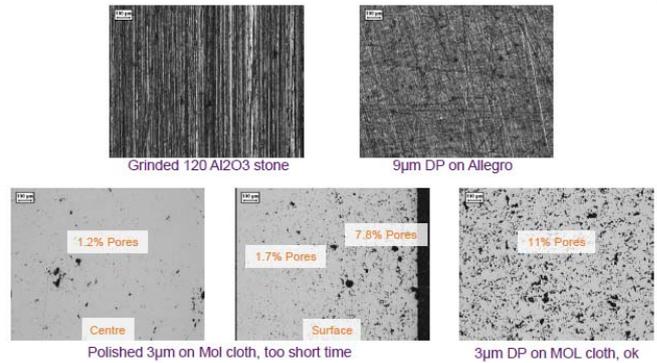
Fig.2: Porosity after grinding and polishing

The first step is to select the sample and to cut the component in such a way that you can get out relevant and right information for the investigation. While cutting, the sample will be mechanically deformed. This needs to be considered during the following grinding and polishing operations. While grinding, the metallographic samples will be grounded to the depth of un-deformed region. Polishing is another important step and it is different in PM materials as it contains pores. During cutting and grinding the pores will be smeared together. In order to open up the pores and be able to see the true porosity the samples needs to be polished (Fig. 2). Here it is important that the samples are polished the right time so that the pores are open correctly. If the polishing time is too short the pores will not be opened and if the time is too long the pores will be larger than they are in reality (Fig. 3). Partial or too much opening of pores may mislead to wrong conclusion of density
